## Ultrasonographic Examination of Patella

Turgay Yılmaz KILIC, Ozge DUMAN ATILLA

*Department of Emergency Medicine, Tepecik Training and Research Hospital, Izmir*

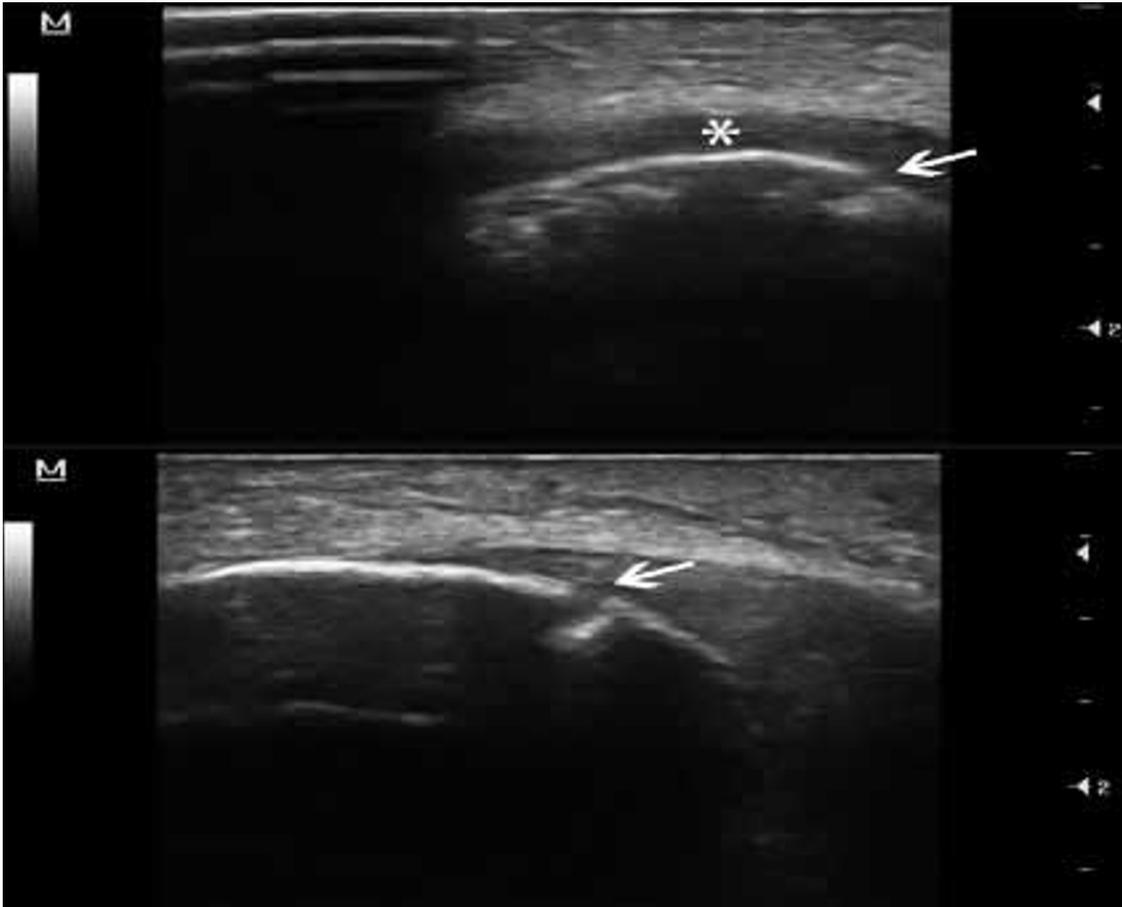
**Figure 1.** Cortical disruption (arrow) and hematoma (asterisk) of patella with longitudinal ultrasonography view.

A 52-year-old female patient presented to the emergency department (ED) complaining of knee pain after falling. Upon admission to the ED, vital signs of the patient were normal. Physical examination revealed mild swelling and tenderness on the right patella, limitation of motion of the knee, and difficulty walking. Neurovascular examination was within normal limits. Bedside ultrasonographic examination (Mindray® M5, Color Diagnostic Ultrasound System, China) was performed before X-rays (Figure 1). [see page 131 for diagnosis]

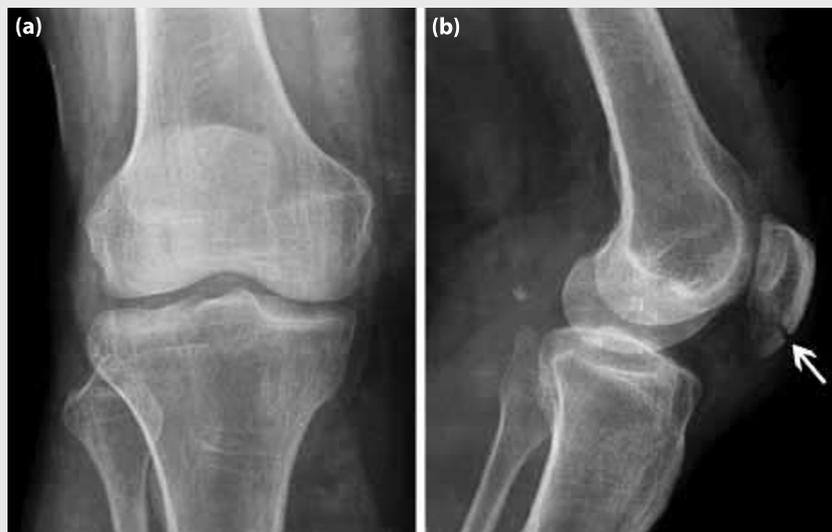
**Figure 2.** (a) Anteroposterior knee radiography. (b) Lateral knee radiograph shows transverse fracture of the patella.

In our case, standard anteroposterior and lateral knee radiographs were obtained after ultrasonographic examination (Figure 2). The patient who underwent consultation at the orthopedic clinic was prescribed a conservative treatment consisting of rest, ice, immobilization with a cylinder cast from the groin to the ankle, keeping the knee in extension, and non-steroidal anti-inflammatory drugs.
